Site 348 Atlantic Breeze Condominiums

Great Marsh Coastal Wetlands Restoration Plan
Rapid Technical Assessment Site 348

Site 348: Atlantic Breeze Condominiums, Salisbury, MA

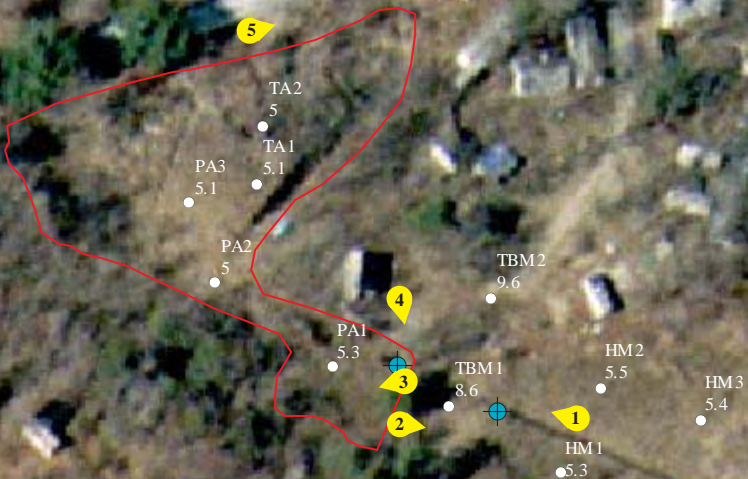
Structure conditions: The existing berm is approximately 4 ft in height and 8 ft in width. It is generally well vegetated with small trees but shows some signs of erosion from past storm events. Overall the berm is in fair condition. The single culvert through the berm consists of a 22 ft long, 12 in diameter cast iron pipe. There are no headwalls or scour protection at the culvert ends, however, no signs of scour were observed. Tidal flow into the culvert would be enhanced with the maintenance of the ditch below the berm. The culvert is in fair overall condition. The outlet of a recently installed water quality structure (Vortech) discharges into the wetland just upstream of the berm. The original function of the berm is unknown.

Photo 1 - View of Berm and Restricted Marsh Beyond

Overall, the existing impairments are considered severe. Removal of a portion of the berm within the condominium parcel along with maintenance and/or cutting of additional ditches would reduce the tidal restriction during larger tide events and reduce the impounded conditions which likely further reduce salinity levels within the potential restoration site. These measures could dovetail with the currently permitted herbicide control measures to reduce *Phragmites* coverage within the restoration area. These steps will also reduce the fire safety hazard associated with *Phragmites* and improve fish foraging habitat. The surrounding development was constructed above the elevation of the predicted 100-year flood so there are no low-lying property concerns.
